Home Inspection Report

Advance Inspection Service

**3101 DEVONSHIRE
PLANO, TX 75075**

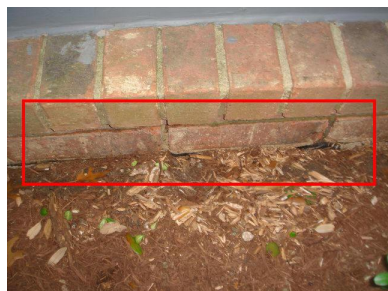
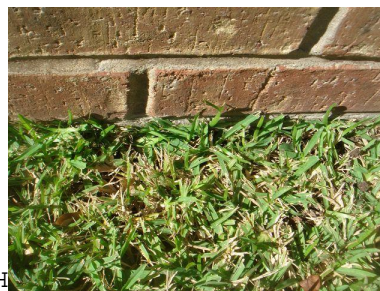
SOIL GRADE IS TOO HIGH ALONG RIGHT SIDE OF HOUSE AND ALONG BACK WHICH IS CONDUCIVE TO TERMITES AND COULD ALLOW WATER PENETRATION;

GRADE TOO HIGH

A WATERING PROGRAM USING SOAKER HOSES AROUND ENTIRE PERIMETER OF HOUSE APPX. 1 TO 1 1/2 FEET FROM FOUNDATION AND SET TO COME ON FOR ABOUT ONE HOUR EVERY THIRD DAY THAT IT DOES NOT RAIN WILL LESSEN SOIL MOVEMENT AND CRACKING;

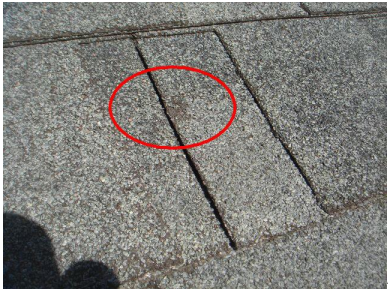
TREE LIMBS ARE TOUCHING ROOF SHINGLES AT BACK; SOME AREAS OF AGRANULATION AT FRONT;
FOR FURTHER EXAMINATION OF ROOF A ROOFING COMPANY SHOULD BE ENGAGED;

AGRANULATION

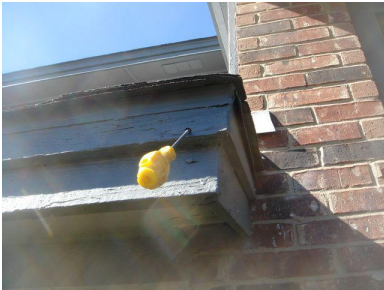
ROT IN DRIP BOARD AND FASCIA ON RIGHT SIDE OF ENTRY PORCH OVERHANG;

ROTTED

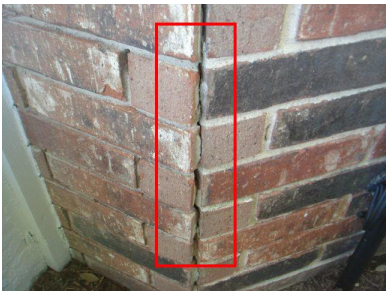
MORTAR IS MISSING IN BRICK JOINTS AT BACK RIGHT CORNERS OF HOUSE
;SHEETROCK SEPARATIONS IN ENTRY HALL AND IN FAMILY ROOM;;

MORTAR MISSING

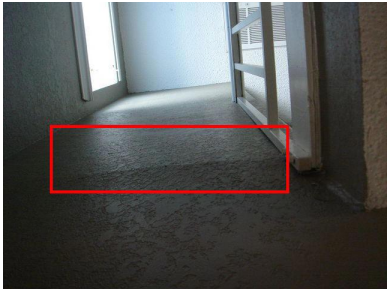
SEPARATION

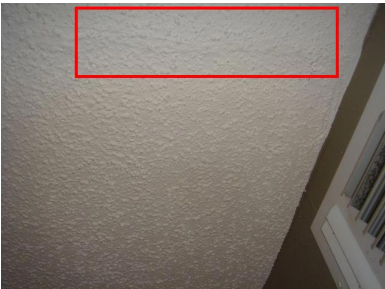
CRACK IN CEILING IN KITCHEN;

CRACK

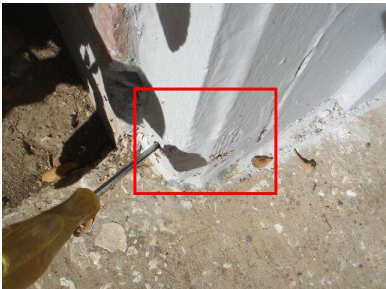
ROT IN GARAGE DOOR FRAMING;

ROT

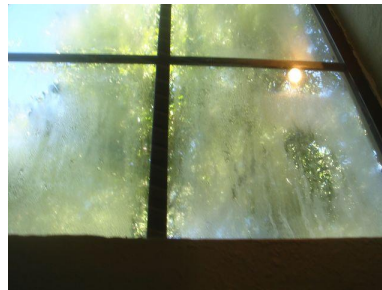
FOGGED

NOTE: IN SOME CASES WINDOWS THAT ARE VERY DIRTY MAY APPEAR TO BE FOGGED...SUGGEST ALL BE CLEANED AND CHECKED.)

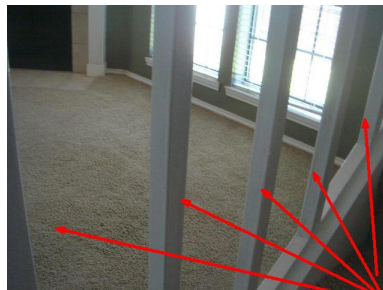
VERTICAL SPACINGS BETWEEN RAILS IS TOO WIDE;

TOO WIDE APART

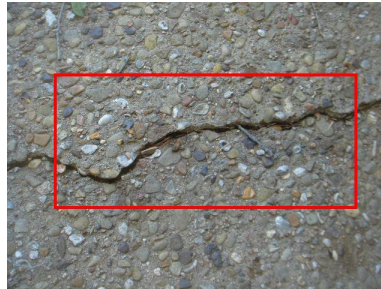
CRACKS IN BACK PORCH SLAB AND IN GARAGE FLOOR;

CRACK

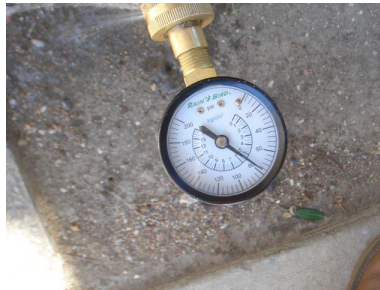
70-80 P.S.I.

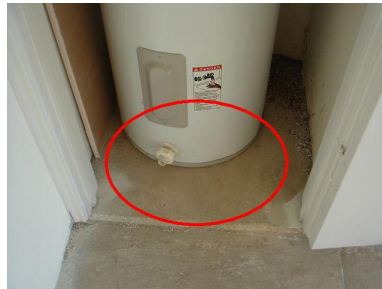
WATER HEATER IGNITION SOURCE IS NOT RAISED THE REQUIRED 18 INCHES ABOVE GARAGE FLOOR OR ROOM ADJACENT TO GARAGE;
TEMPERATURE AND PRESSURE RELIEF VALVE DID NOT OPEN WHEN TESTED;

NOT RAISED

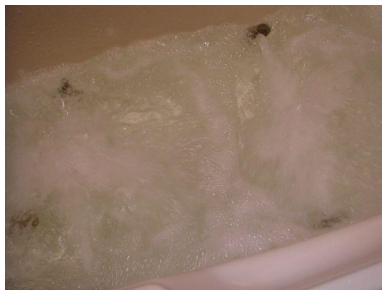
COLD SIDE FAUCET AT JACUZZI TUB HAS NO STOP;
NO DOOR TO PROVIDE READY ACCESS TO PUMP AND MOTOR WERE FOUND, COULD NOT CHECK GROUND FAULT PROTECTION;

TUB RUNNING

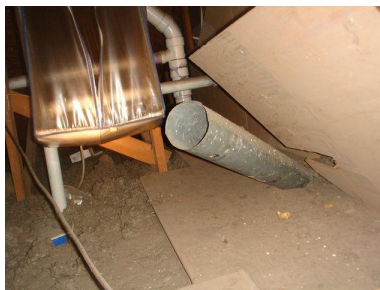
UPPER BACK BATHROOM VENT TERMINATES IN ATTIC SPACE;

BATHROOM VENT PIPE

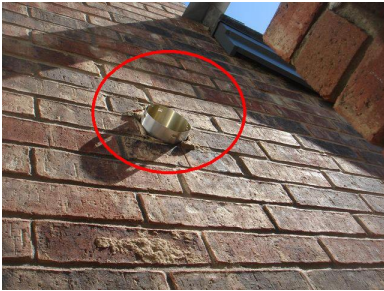
VENT IS OPEN ON LEFT SIDE OF UNIT;

???OPEN??
