## **Home Inspection Report**

**4410 COWAN STREET DALLAS, TX 75209**

### PROPERTY INSPECTION REPORT

| Prepared For: | LUCIA LUGO | | |
|---|--|---|--|
| Concerning: | 4410 COWAN STREET, DALLAS, TX 75209 (Address or Other Identification of Inspected Property) | | |

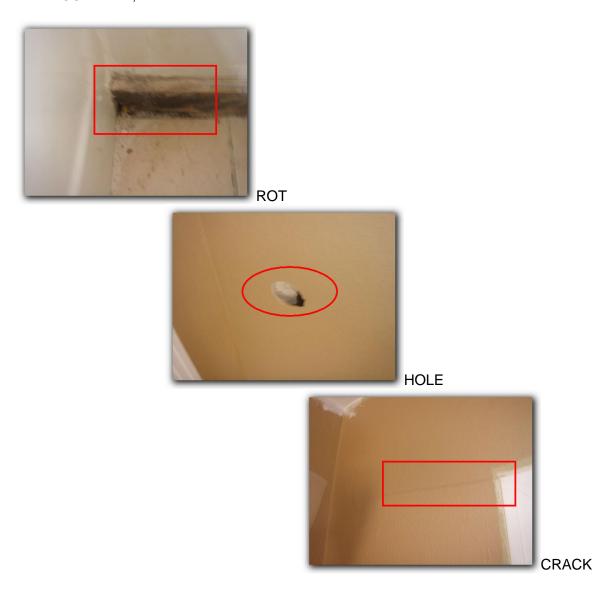
OPENING IN SIDING AT BACK OF HOUSE; MANY TILES ARE BROKEN AT BACK, LEFT, RIGHT, AND FRONT;

ROT IN FLOOR MOLDING BOARD IN BATHROOM BETWEEN TUB AND COMMODE; HOLES IN WALLS IN BACK LEFT BEDROOM AND IN WATER HEATER CLOSET; CRACK IN BATHROOM WALL;

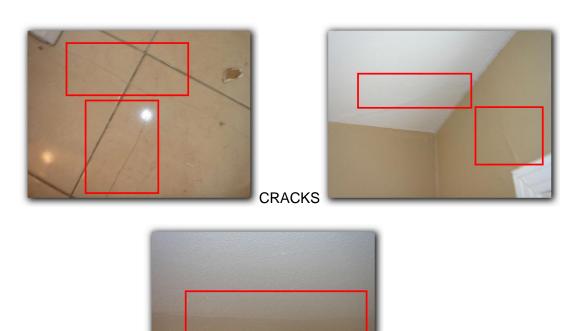
DEFLECTED

CRACKS IN FLOOR TILES AND IN CEILING IN BATHROOM AND IN KITCHEN; DEFLECTIONS AND CRACKS IN CEILING IN FRONT LIVING ROOM; CRACKS IN CEILING AND WALL IN BACK RIGHT(UTILITY) ROOM;

FLOORING IS WATER DAMAGED AND ROTTED UNDER BATHROOM, WATER STAINED UNDER KITCHEN AND UNDER WATER HEATER;

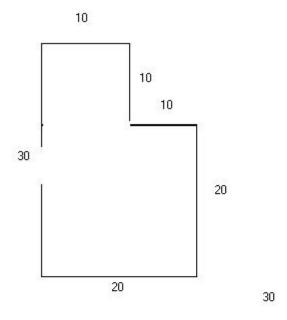
APPX..100 LINEAR FEET OUTBUILDING 120 LINEAR FEET .. MAIN HOUSE
